SUBJECT: February 2015 Inspection Report for the former Cornell Dubilier Electronics (CDE)

Superfund Site, South Plainfield, New Jersey

DATE: February 19, 2015

# 02-13-2015 Cornell-Dubilier Electronics

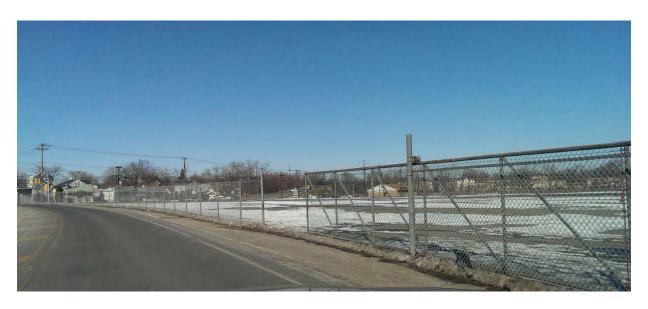
(Rolling gate along Spicer Avenue was open when getting on-site)
